Manhole Inspection Summary

Manhole # S35AA_034MH

Insp Date: **11/13/07 8:55 AM**

Location Address: **n.hunter**

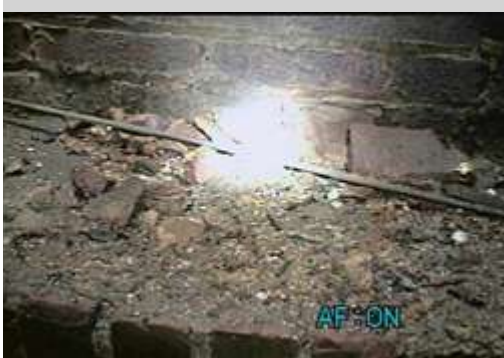
Misc. bench debris

bench debris

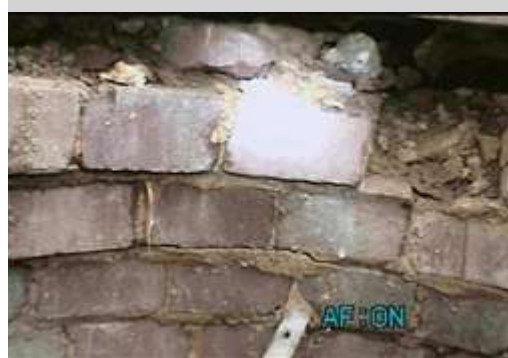
Defect 2

Condition: ☐ Sound ☒ **Cracked** ☐ Root Intrusion ☒ **Loose Brick** ☐ Deteriorated

crack in corbel

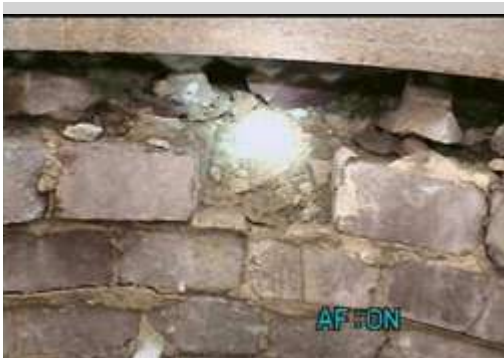
Defect 1

frame adj & missing brick in corbel

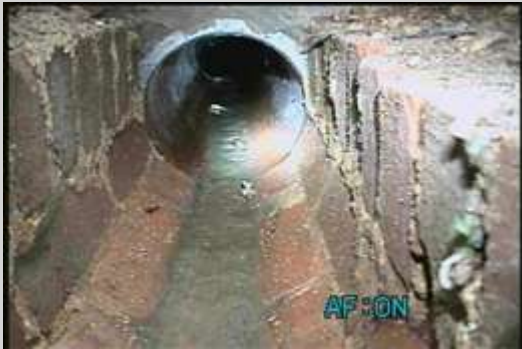
12 O'Clock Outflow

8 in. Circular Gravity Sewer
Pipe Out @ 12 O'Clock

Pipe Material: **Clay** ☐ Pipe Lined

Invert Depth: **8.30** (ft.) Flow Characteristics: **Slow**

Infiltration: **None** Pipe Seal Cond: **Unknown**

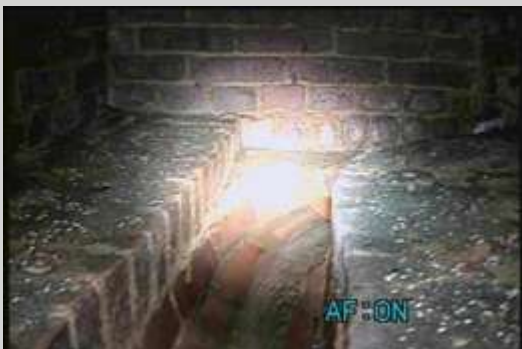
6 O'Clock Inflow

8 in. Circular Gravity Sewer
Pipe In @ 6 O'Clock

Pipe Material: **Clay** ☐ Pipe Lined

Invert Depth: **8.20** (ft.) Flow Characteristics: **Slow**

Infiltration: **None** Pipe Seal Cond: **Unknown**
